TECHNICAL NOTE

No. 1246

WIND-TUNNEL INVESTIGATION OF ICING OF AN ENGINE
COOLING-FAN INSTALLATION

By James P. Lewis

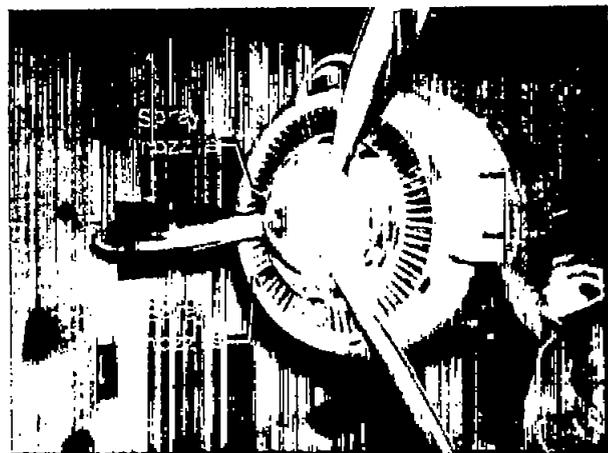
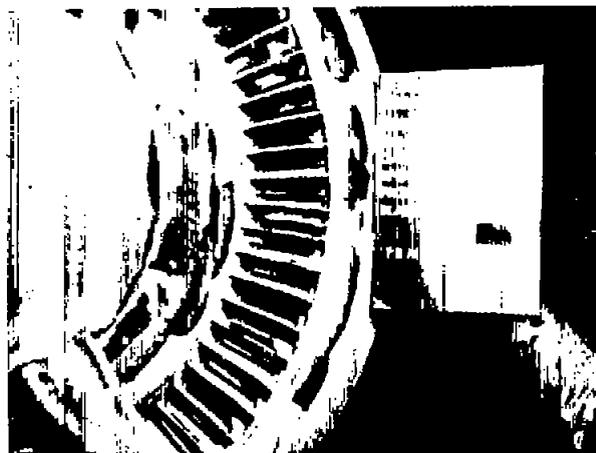
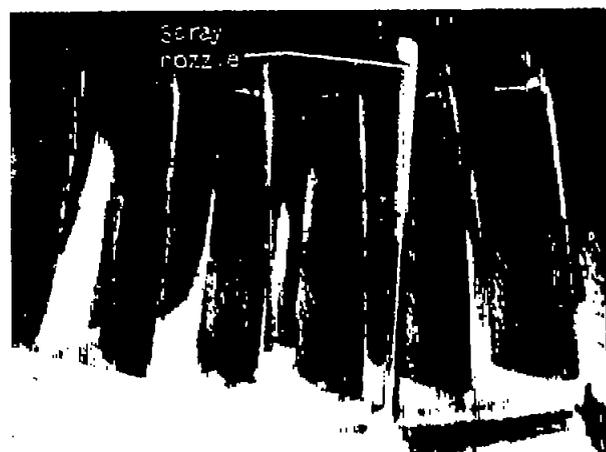
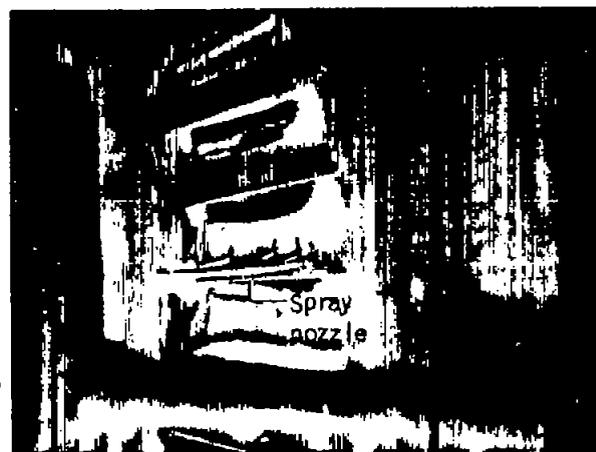
(a) General view of installation.

(b) View showing de-icing of fan blades.

(c) Close-up showing de-icing of fan blades.

(d) View looking forward through stator vanes.

Figure 19. - Views showing effect of alcohol de-icing of cooling-fan installation at air temperature of 14° F, liquid-water content of 0.5 gram per cubic meter, fan speed of 952 rpm, and alcohol flow of 1.5 pounds per minute.

approximately the same icing and speed conditions and with the second spray configuration, no improvement in de-icing was apparent (fig. 18). Although the convex face of the fan blades was almost completely clear of ice, heavy deposits of slush were as much as three-fourths inch thick at the concave-face trailing edge. The stator vanes again had large formations of wet ice and were approximately 50-percent blocked. At a medium icing condition (air temperature, 14° F and liquid-water content, 0.5 gram/cu m) and an alcohol flow of 1.5 pounds per minute, the fan blades were almost fully de-iced. (See fig. 19.) Medium formations of wet ice were found on the stator vanes immediately behind the spray tubes and only a thin coating of ice was found on the rest of the stator blades. When the alcohol flow was increased to 2.3 pounds per minute, the fan blades were again almost completely de-iced (fig. 20). Large deposits accumulated, however, on all the stator vanes. As shown by the photographs of all the alcohol de-icing (figs. 16 to 20), the alcohol-diluted ice thrown off the fan blades impinged on the stator vanes where it remained and refroze. For all conditions, configurations, and flows investigated, the use of alcohol as a de-icing agent proved ineffective because of the marginal de-icing of the fan blades and the large ice deposits obtained on the stator vanes. It is estimated that no practical amount of alcohol would satisfactorily preserve fan performance under all icing conditions.

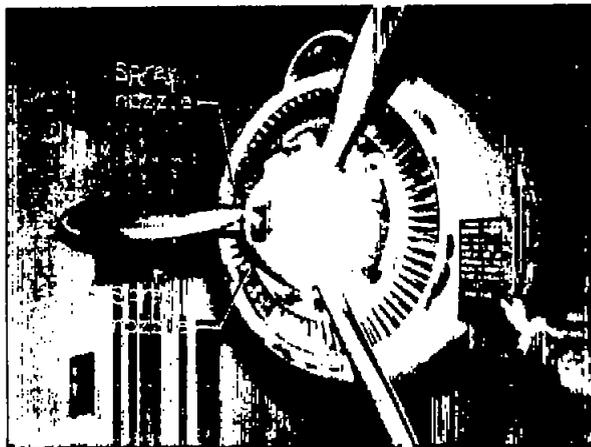
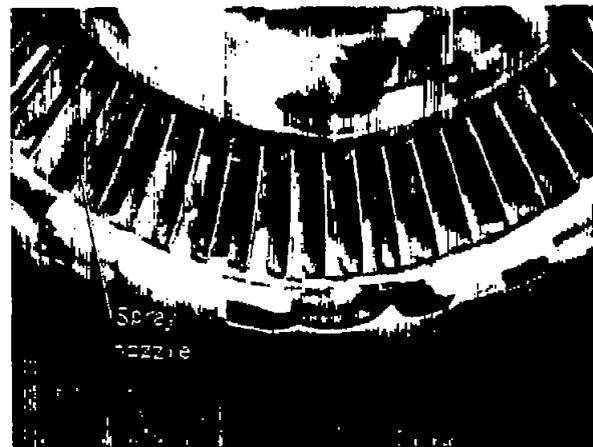
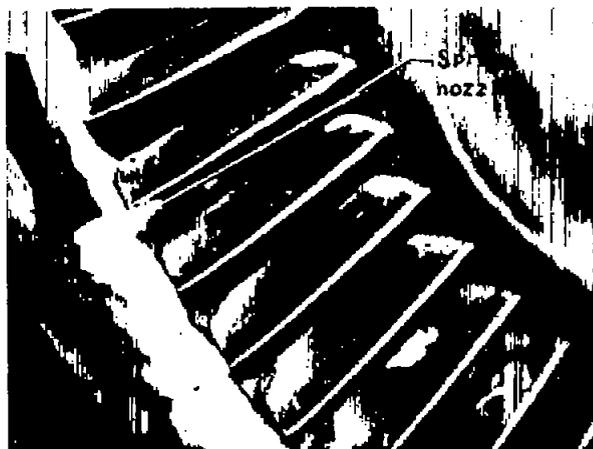
(a) General view of installation.

(b) View showing de-icing of fan blades and throwback on stator vanes.

(c) Close-up of fan blades.

(d) View looking forward through stator vanes.

Figure 20. - Views showing effect of alcohol de-icing of cooling-fan installation at air temperature of 13° F, liquid-water content of 0.5 gram per cubic meter, fan speed of 950 rpm, and alcohol flow of 2.3 pounds per minute.

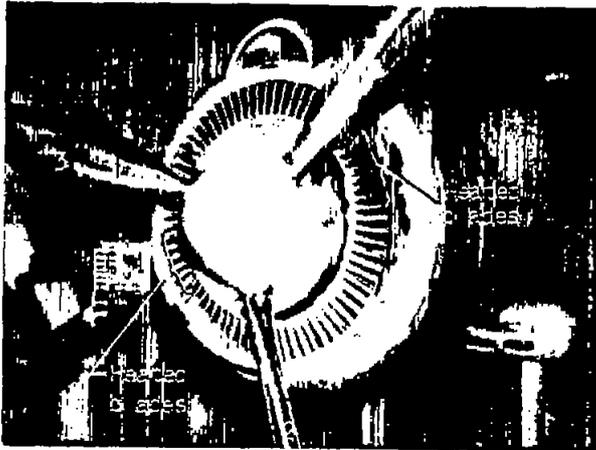
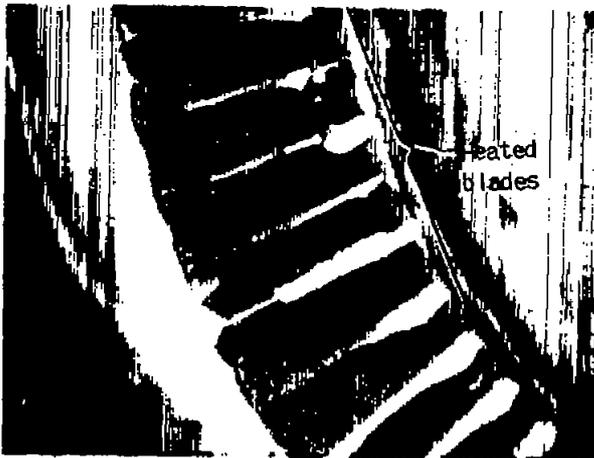
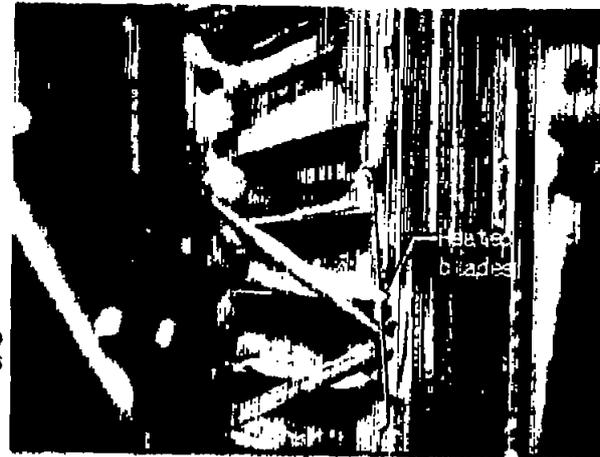
(a) General view of installation.

(b) Close-up of unheated fan blades.

(c) Close-up of heated fan blades.

(d) View looking forward showing heated and unheated stator vanes.

Figure 21. - Views showing de-icing of cooling-fan installation by electric blade heaters after 5-minute run at air temperature of 15° F, liquid-water content of 0.5 gram per cubic meter, fan speed of 954 rpm, and power density of 5 watts per square inch.

Electrical heat de-icing. - Photographs showing the results of the use of electric blade heaters are presented in figures 21 to 25. As only a few of the fan blades and stator vanes were heated, no fan-performance data were obtained. With an air temperature of 15° F, liquid-water content of 0.5 gram per cubic meter, fan speed of 954 rpm, and a power density of 5 watts per square inch, fairly complete de-icing of the heated fan blades resulted. (See fig. 21.) The small amount of ice at the root of the leading edge was caused by ice bridging over from an unheated part of the blade. It should be noted that the group of heated fan blades behind propeller blade 1 were partly shielded from icing by the blade shank. The de-icing of the stator vanes was only marginal with rough ice building up near the trailing edge. When the power density was increased to 6 watts per square inch (fig. 22), some improvement in the de-icing of the stator vanes resulted but rough ice still collected at the trailing edge. At a higher temperature and liquid-water content (fig. 23), complete de-icing of the heated fan blades was obtained after 5 minutes of icing. The de-icing of the stator vanes was again marginal. The effects of electrical heating at two icing conditions, each of 10-minute duration, are shown in figures 24 and 25. Both

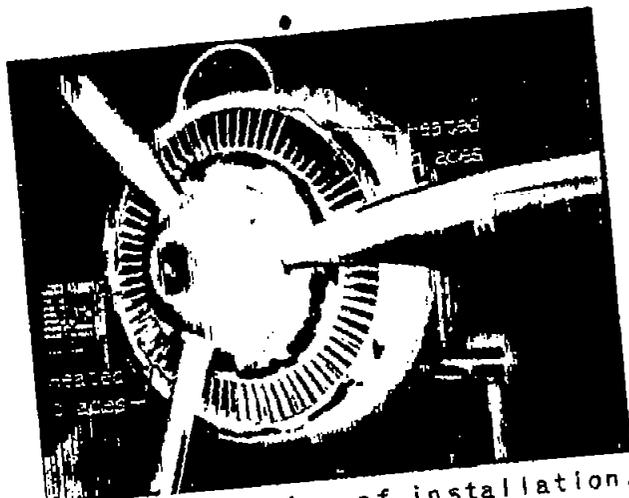
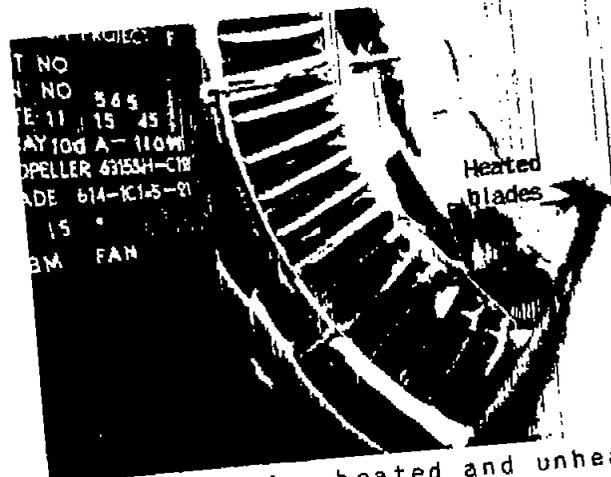
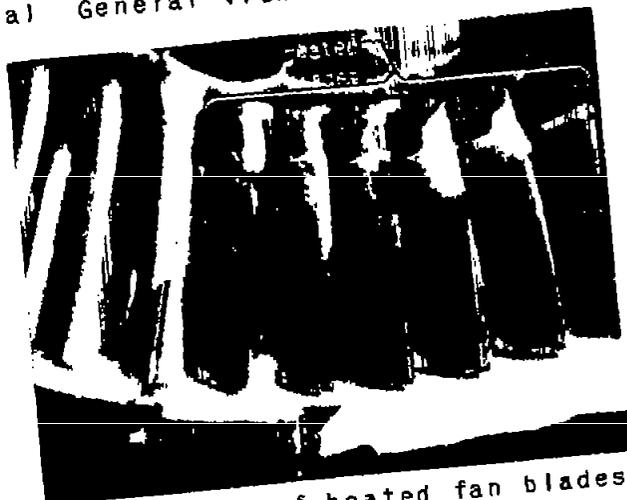
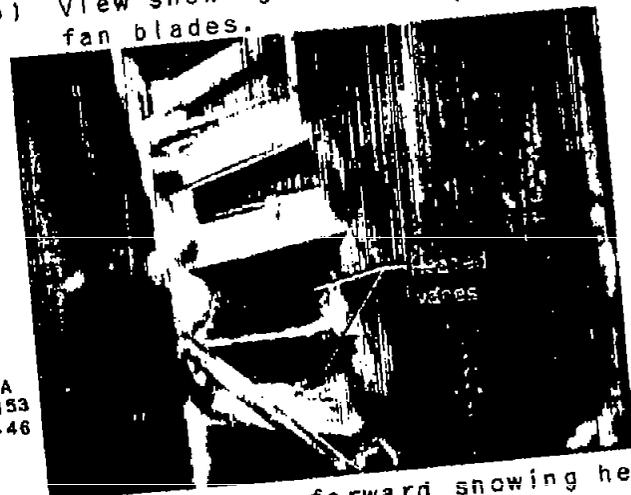
(a) General view of installation.

(b) View showing heated and unheated fan blades.

(c) Close-up of heated fan blades.

(d) View looking forward showing heated and unheated stator vanes.

Figure 22. - Views showing de-icing of cooling-fan installation by electric blade heaters after 5-minute run at air temperature of 16° F, liquid-water content of 0.6 gram per cubic meter, fan speed of 950 rpm, and power density of 6 watts per square inch.

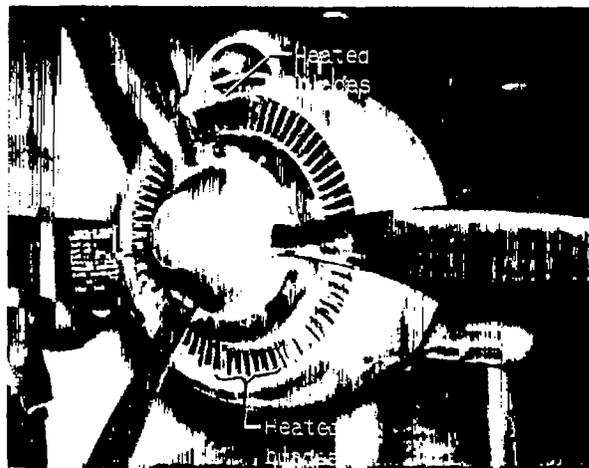
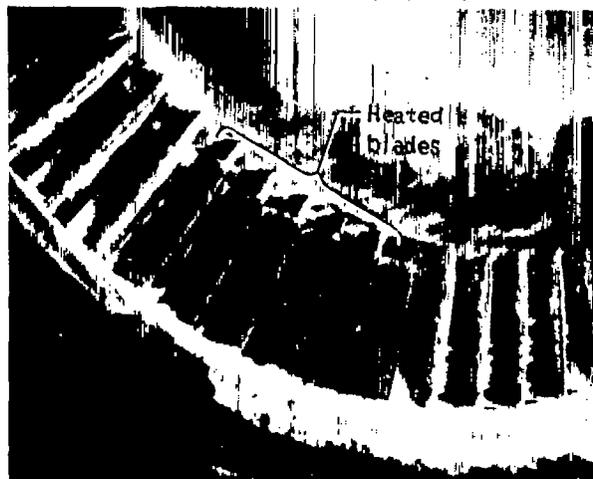
(a) General view of installation.

(b) Close-up of heated fan blades.

(c) Close-up of unheated fan blades.

Figure 23. - Views showing de-icing of cooling-fan installation by electric blade heaters after 5-minute run at air temperature of 28° F, liquid-water content of 1.2 grams per cubic meter, fan speed of 950 rpm, and power density of 6 watts per square inch.

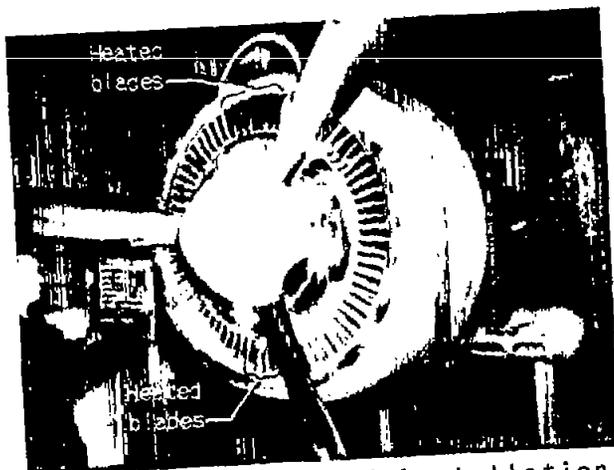
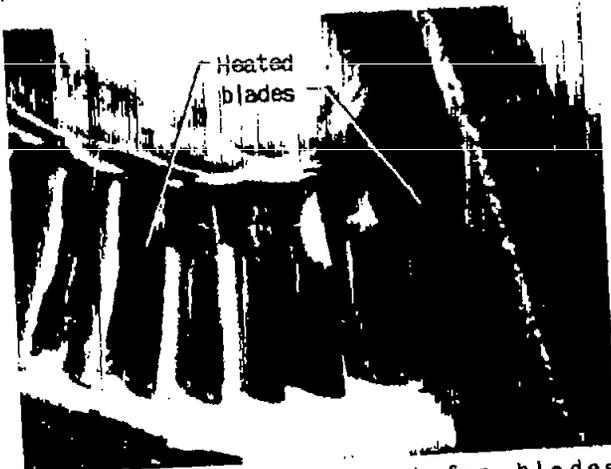
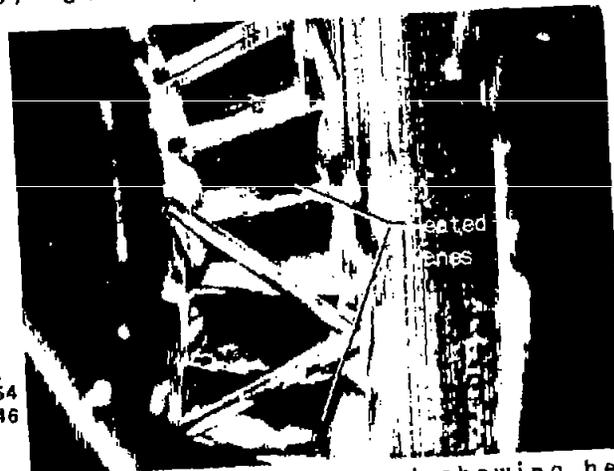
(a) General view of installation.

(b) Close-up of unheated fan blades.

(c) Close-up of heated fan blades.

(d) View looking forward showing heated stator vanes.

Figure 24. - Views showing de-icing of cooling-fan installation by electric blade heaters after 10-minute run at air temperature of 14° F, liquid-water content of 0.5 gram per cubic meter, fan speed of 950 rpm, and power density of 6 watts per square inch.

experiments were made at power densities of 6 watts per square inch with the fan blades almost completely de-iced. At the lower temperature, the de-icing of the stator vanes was marginal and at the higher temperature and liquid-water content, the de-icing of the stator vanes was completely ineffective.

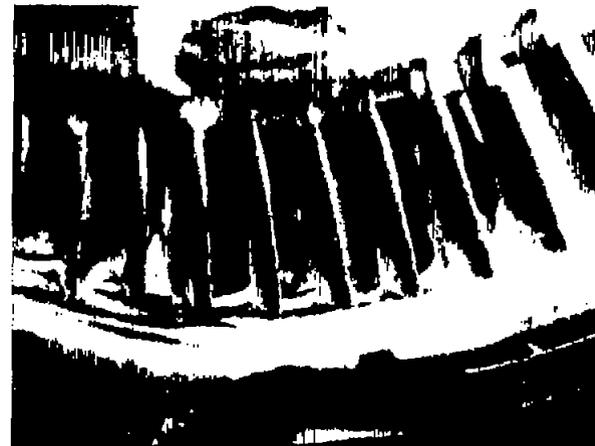
(b) Close-up of unheated fan blades.

(d) View looking forward showing ice formations on heated stator vanes.

Figure 25. - Views showing de-icing of cooling-fan installation by electric blade heaters after 10-minute run at air temperature of 22° F, liquid-water content of 1.0 gram per cubic meter, fan speed of 952 rpm, and power density of 6 watts per square inch.
